California State Board of Equalization
450 N Street, Sacramento, California

Mold Remediation – 14th Floor
Closure Report Addendum
Project No. 2372.02-572

Addendum Date: October 31, 2012

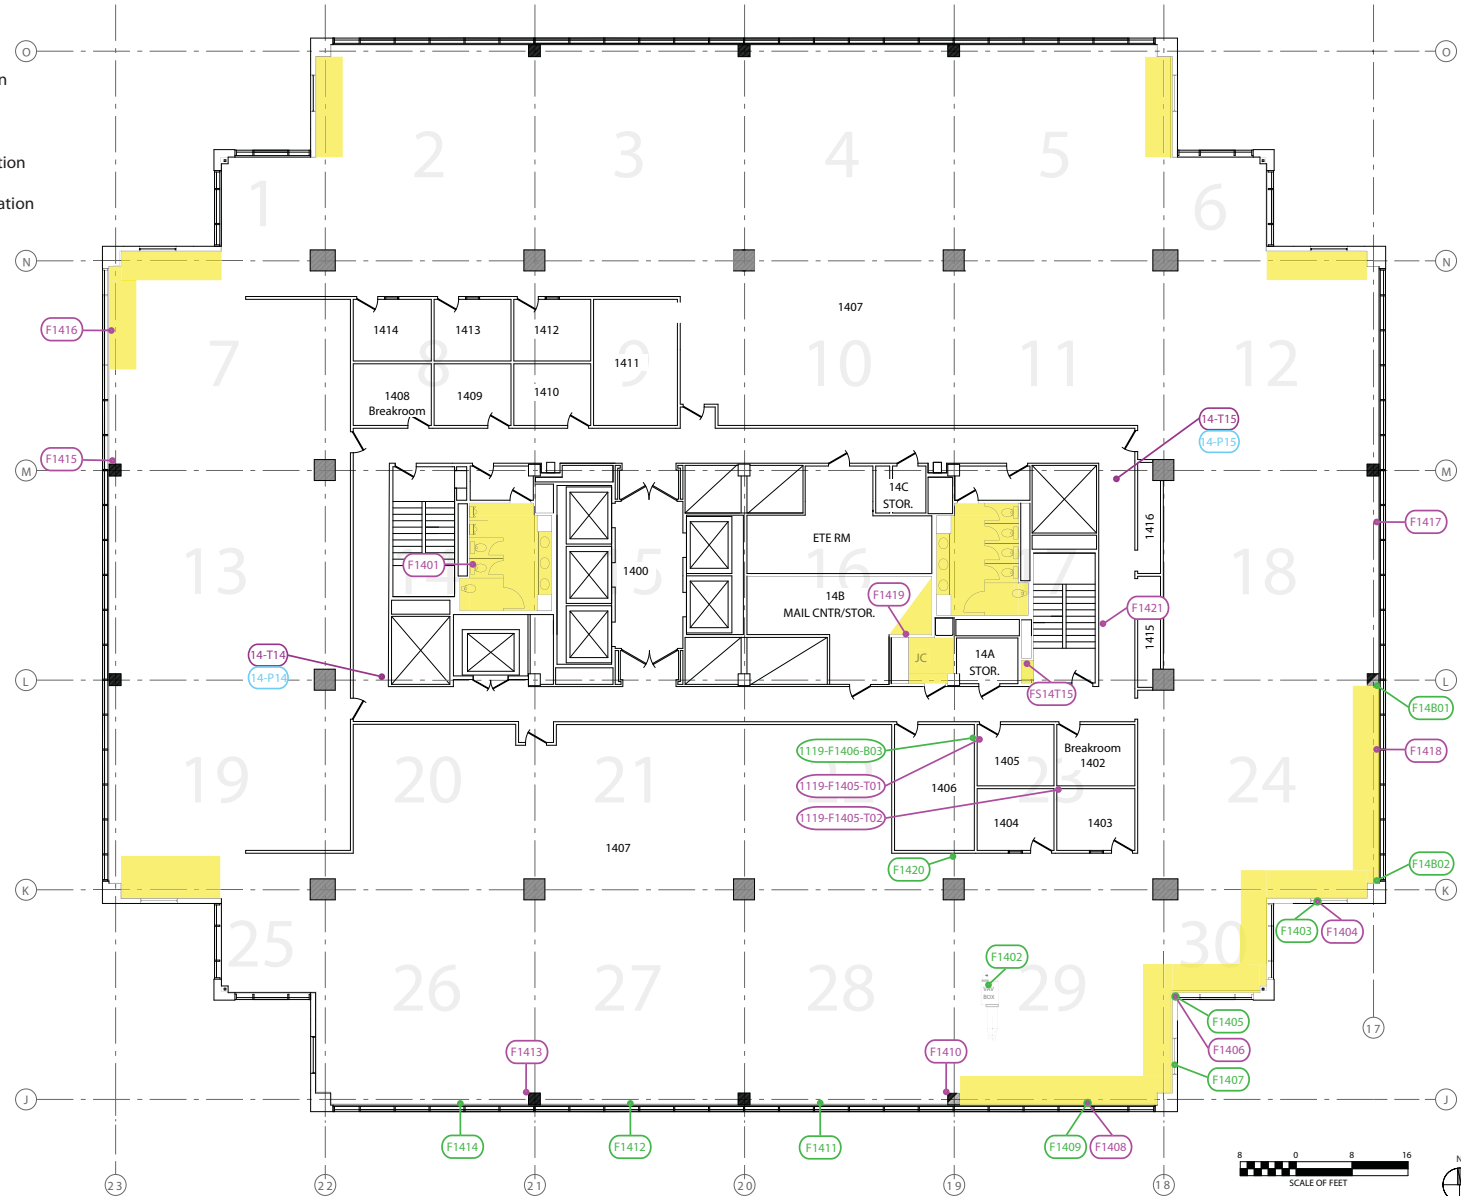
Subsequent to the completion of the closure report, a need for additional investigation and/or remediation activities was identified. Identified areas were subjected to sampling. Using a combination of surface tape lift and/or bulk samples, LCD tested stains on walls and other building materials to determine if the stains were indicative of mold growth. The sample locations are depicted in a revised Figure 2 attached to this addendum.

Containment and Sample Locations (Oct 2012)
Board of Equalization Building, Mold Remediation
450 N Street, Sacramento, California

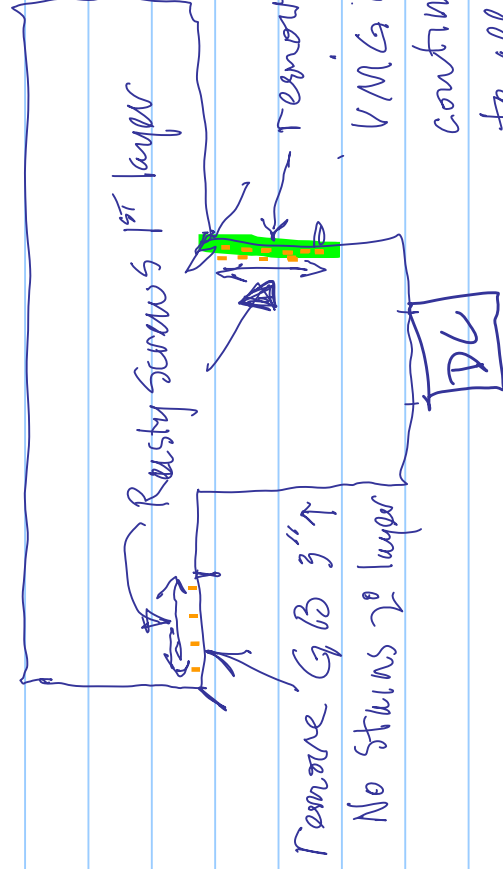
14 B

VMG on 2nd layer GB

01:00 1405 VCT Removal underway - completed 2:00
14B remove 1st layer GB at Entry E ~~Wall~~ to 4'
where VMG is visible on 2nd layer GB at 2'

remove 1st GB ↑ x 3'

continue removing 1st layer

to allow clean + encaps 2nd layer

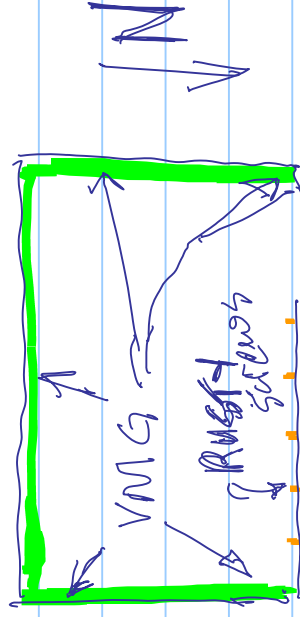
1405

VMG all lower walls
Remove 1' \uparrow entire

Remove

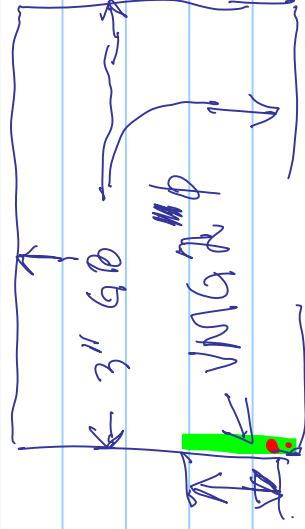
N \uparrow
B04

VMG wall at S CB
rust screws other walls
remove 3' entire = No VMG

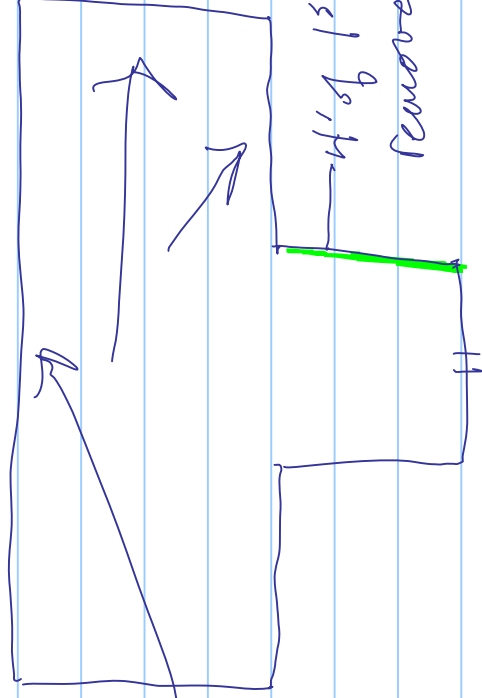
Containment
1405

ID 2 small stains in wall cavity - collect 2 samples one in NW area common w/ 1406 and one in SE area common w/ 1403 - test FP moisture content

stain ceiling tiles

stain FP at pipe hanger
directly above

stain GB in wall cavity
